RE: Site Inspection, Graymont Western US, Inc., Cricket Mountain Mine, M/027/006, Millard County, Utah

Date of Inspection: March 1, 2002  
Time of Inspection: 9:30 to 11:30 AM  
Conditions: Mostly clear, windy, very cold  
Participants: Terry McIntyre, Graymont; Paul Baker, DOGM

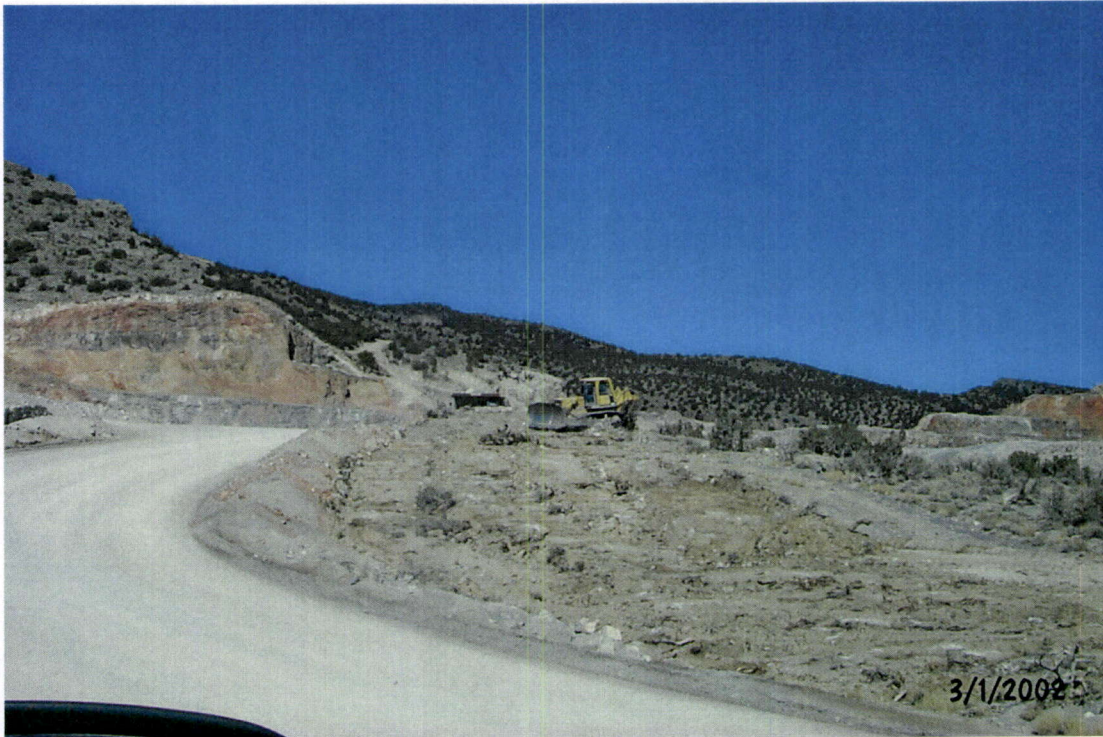
I did not look at the topsoil stockpiles, but topsoil was being scraped away from an area at the Flat Iron Mine while we were there (Photo 1).

Photo 1. Topsoil being salvaged at the Flat Iron Mine.

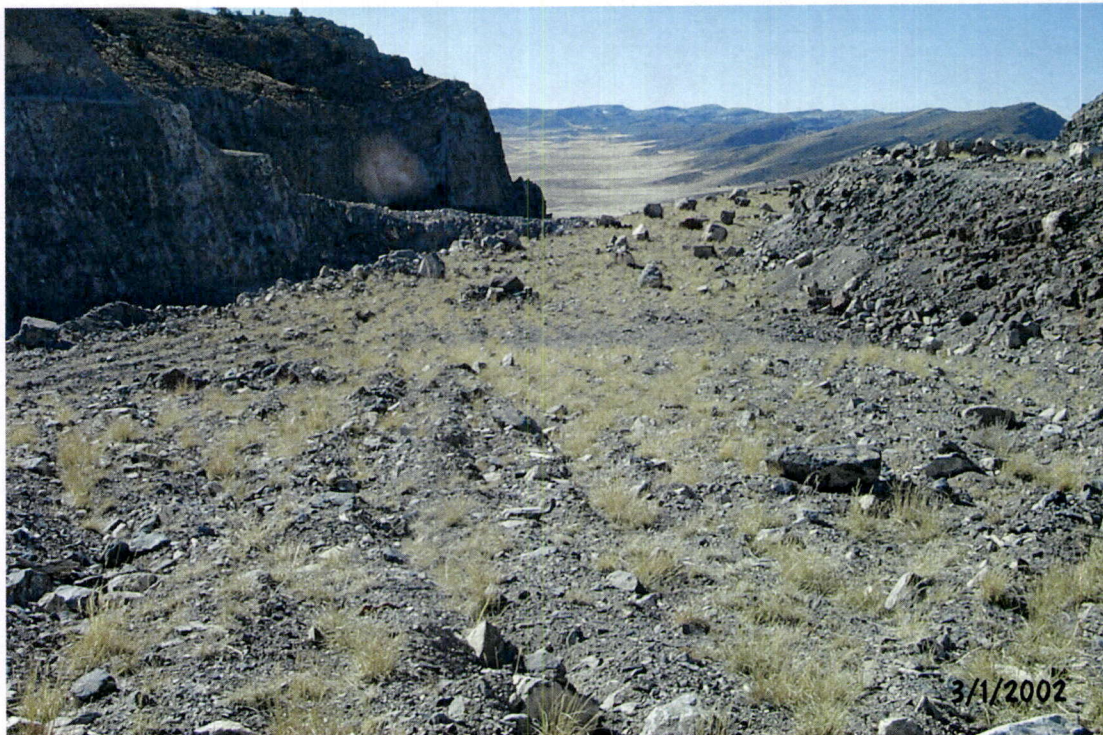
We looked at reclamation on some of the benches at the Poison Mountain Mine. Vegetation in the areas that received topsoil (Photos 2 and 3) is doing much better than areas that were reclaimed only with fines (Photo 4). Dominant species in the reclaimed areas were crested wheatgrass, Russian wild rye, forage kochia, and fourwing saltbush. Other species include Palmer penstemon, bottlebrush squirreltail, and bluebunch wheatgrass. In general, vegetation in the topsoiled areas looks very good.

There are quite a few rocks in the soil matrix in the topsoiled areas, and, in addition, the operator has intentionally placed rocks on the surface of some of the areas (Photos 2 and 3). This increases water infiltration and vegetation growth while enhancing the value of the area for wildlife habitat.

Photo 2. Revegetation on bench at Poison Mountain Mine.

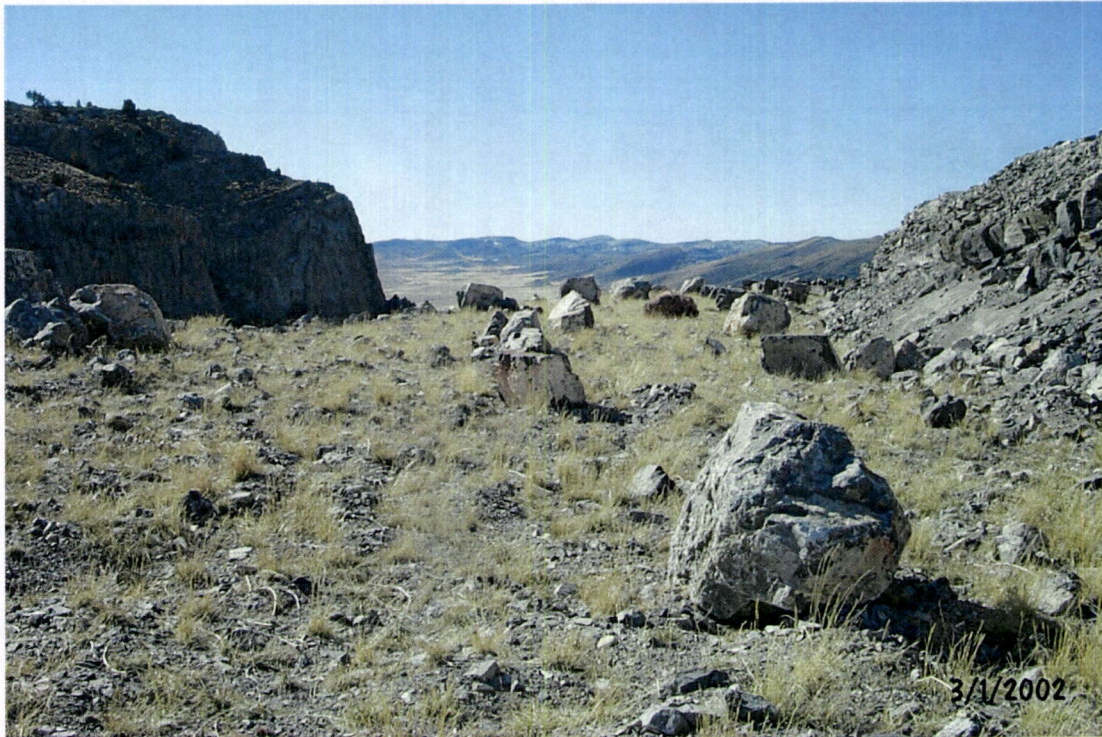
Photo 3. Revegetation on bench at Poison Mountain Mine. Note the intentionally-placed rocks.

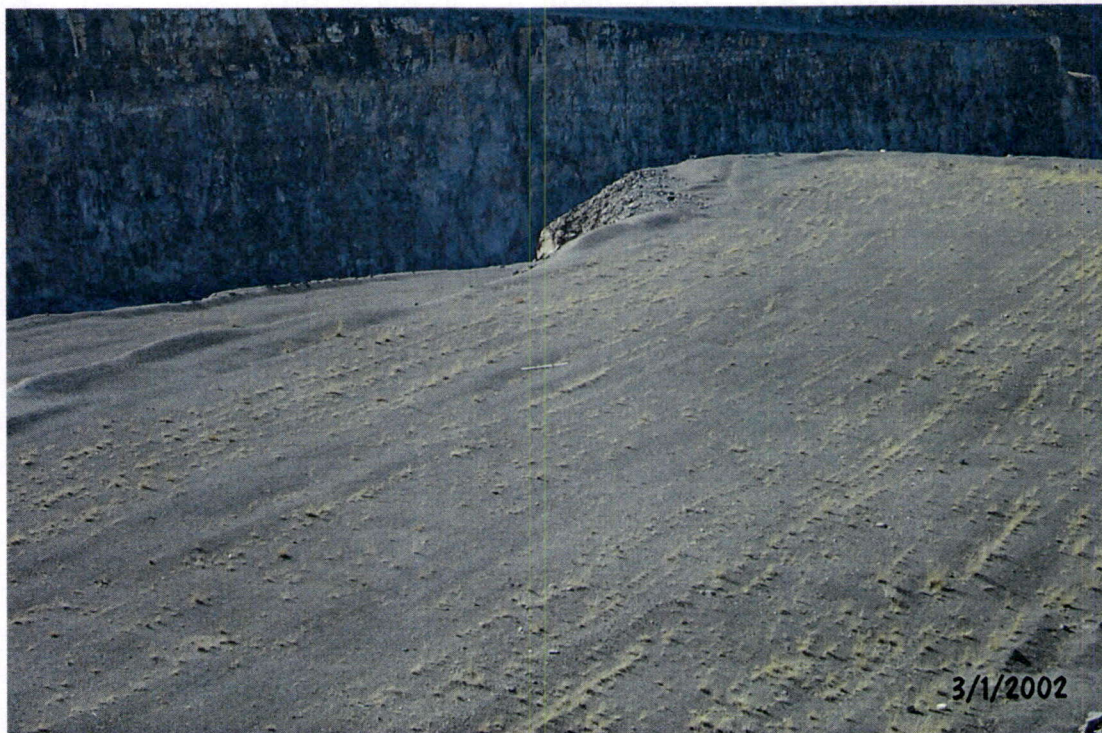
There is not nearly as much vegetation cover in areas that were reclaimed with reject fines for the soil as there is in areas where soil or overburden were used. In the future, fines should not be used alone as a soil substitute.

Photo 4. Revegetation with fines used for soil on a bench of the Poison Mountain Mine.

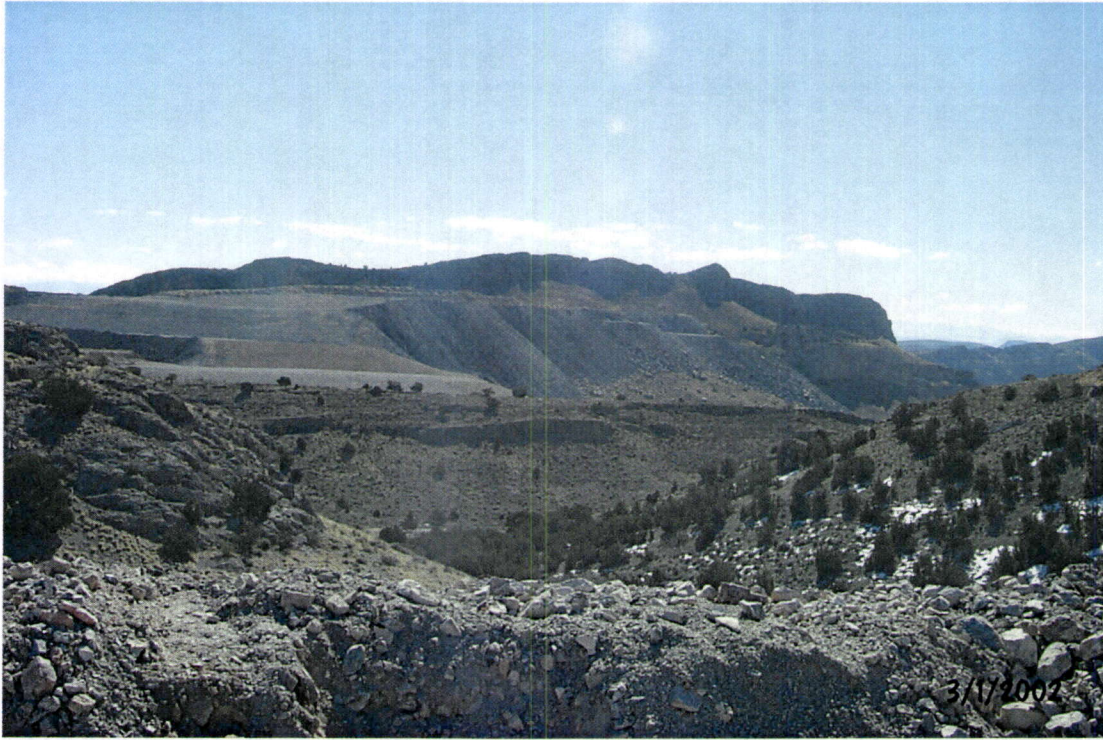
From the Flat Iron Mine, Mr. McIntyre showed me a dump on the west side of the Poison Mountain Mine and asked about whether the dumps need to be regraded (Photos 6 and 7). There are actually two groups of dumps in this area, one on the north which has been mostly regraded, and one on the south which has not. From a distance, it did not appear topsoil had been salvaged in the area of the south dumps. We did not look closely at these dumps, so I do not know whether there are any stability or other reclamation problems with them.

Photo 5. Waste dumps at the Poison Mountain Mine.

The plan contains a map showing the south dump area or at least a portion of it. The map, dated 1991, indicates this area is about five acres, but I suspect the actual disturbed area is more than this. The plan does not contain a reclamation treatments map for this area, so it is impossible to answer the question whether the south dump area needs to be graded. In addition, the legal description in the reclamation agreement does not include the south dump area, so this area may not have been included when last calculating the bond.

Before the Division can make a decision whether the south dump area needs to be regraded, the operator needs to submit a reclamation plan showing how they propose to reclaim this site. The Division could then review this plan and determine whether additional grading needs to be done.

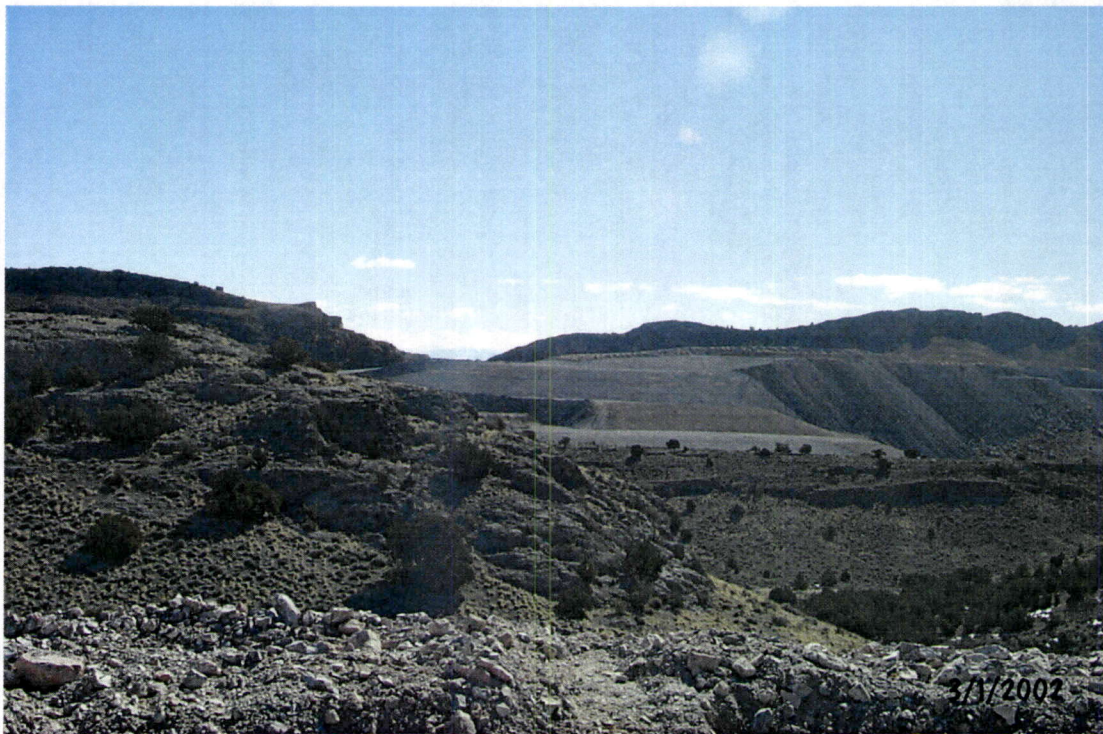
Photo 6. Waste dumps at the Poison Mountain Mine.
